# I'd Like to Fix Your Attic, But I'm Late for Another Appointment: Innovative Approaches to Uncovering the Real-World Practices of Weatherization Contractors

Jared Powell, David Barclay, Alyssa Na'im, Nicole Rosenberg, Michael Strom, Lauren Abraham, and Kailey Pratt, NMR Group, Inc., Somerville, MA

# ABSTRACT

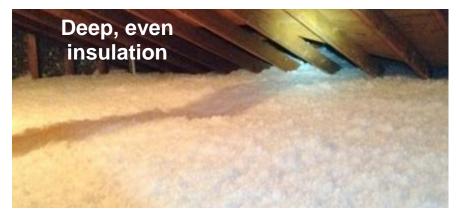
Figure 8. High-quality blown-in attic insulation

Figure 8 shows an example of high-quality blown-in fiberglass insulation in an attic. The insulation was deep, quite level, and installed over a room that was difficult to access from the main attic space. The homeowner reported having to push the insulators to get them to insulate this harder-to-access space, but the final work appeared to be of high quality.

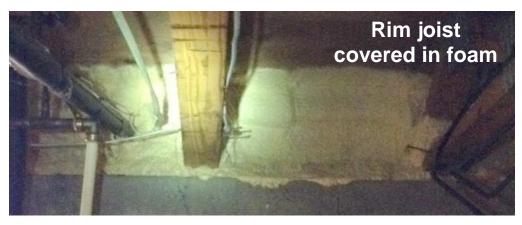
Figure 9. High-quality rim joist air sealing serving as insulation

Figure 9 shows a basement rim joist that was covered by the HES vendor using two-part closedcell spray foam. NMR auditors observed that some HES vendors thoroughly sealed the entire rim joist area with spray foam to achieve higher savings than might be possible with targeting individual penetrations with a spray foam gun/wand.

For rim joist improvements, the quality inspections revealed that some HES technicians did not seal individual penetrations in basement rim joists, but rather coated the entire basement rim joist with spray foam. This increases the vendor's materials cost, but air seals far more effectively than sealing individual penetrations (particularly on old homes). Using a spray-apply material, technicians can more easily seal gaps that are hard to reach with a standard air-sealing foam gun/wand.
