Pop Quiz! LED Lighting Can Generate Significant Savings in Nonresidential Buildings?

2015 IEPEC Conference — Long Beach, California

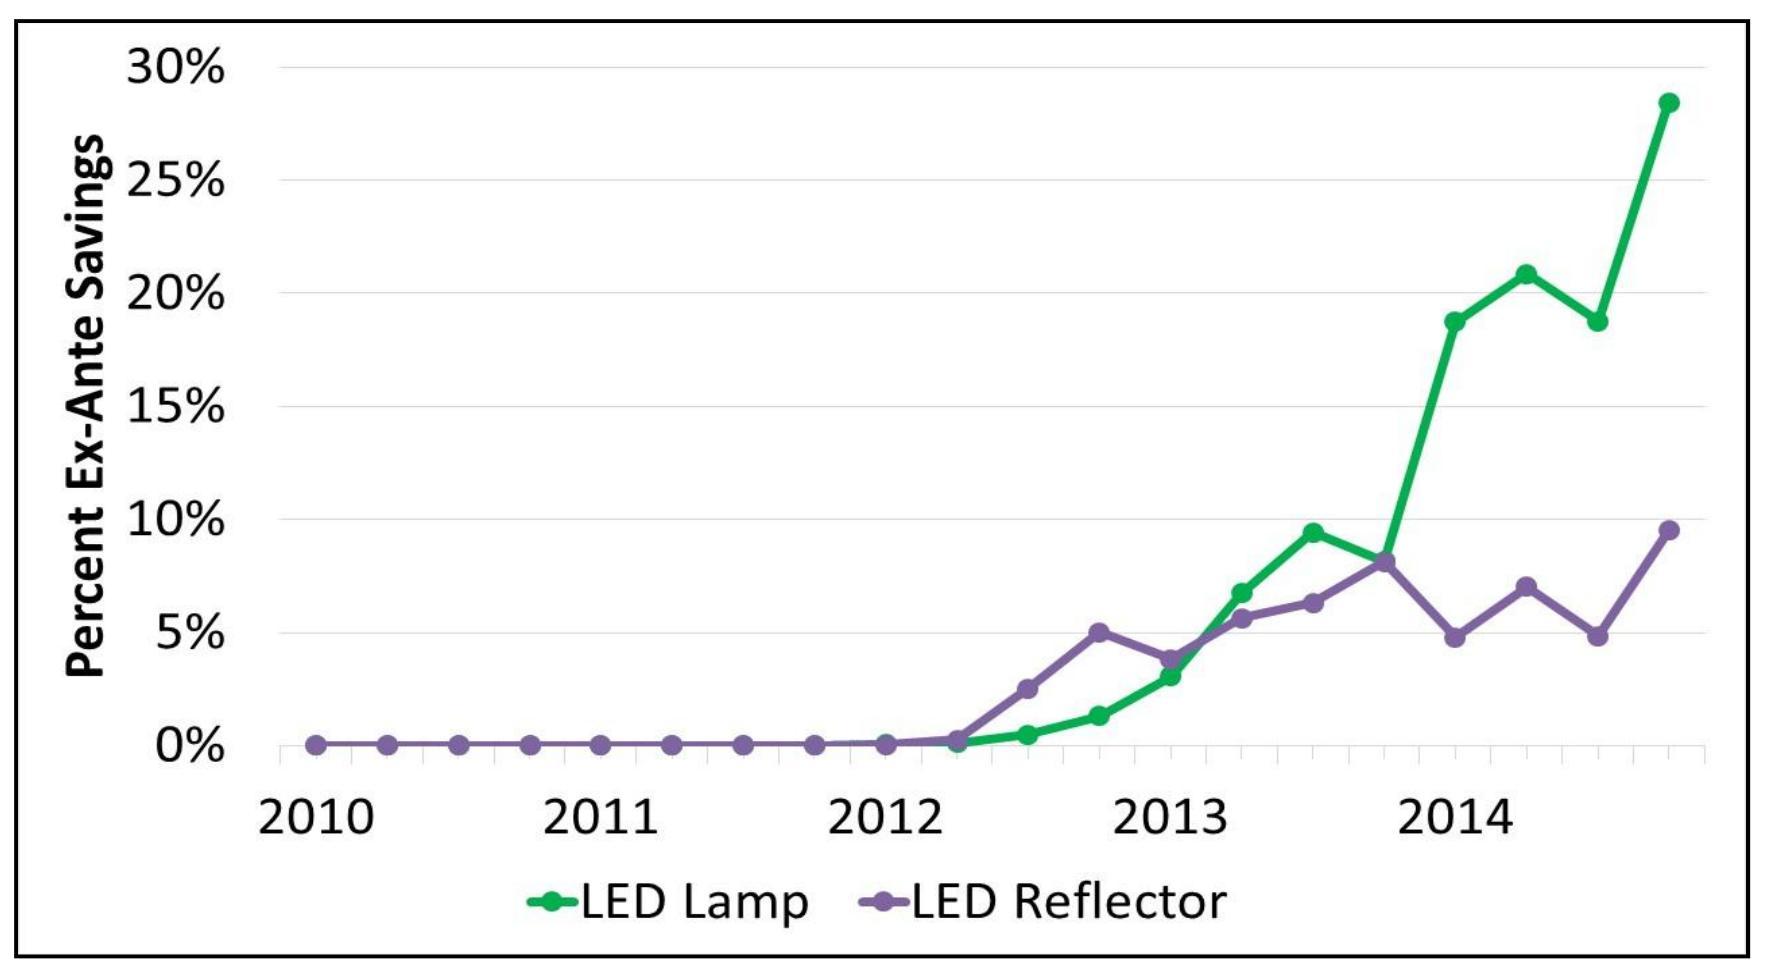
Rebated LED Lamps and Reflector Lamps by 3 California IOUs

Percent ex-ante savings represents all deemed/non-residential/downstream lighting measures

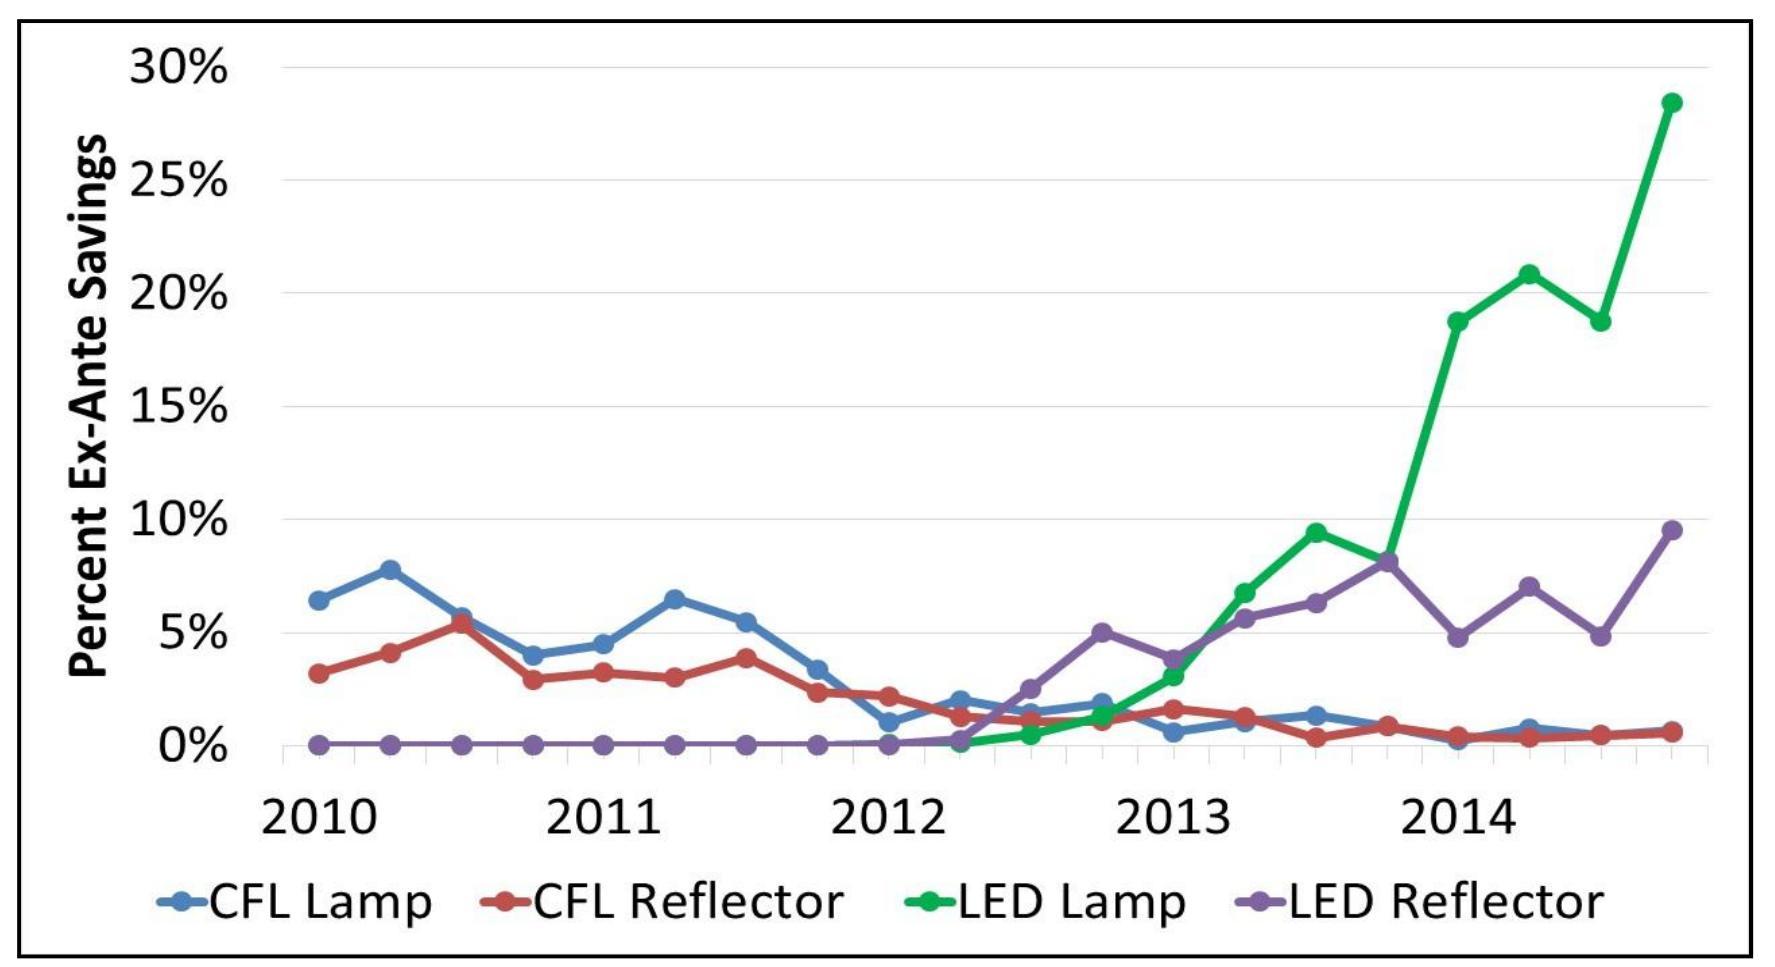
Rebated LED Lamps and Reflector Lamps by 3 California IOUs

Percent ex-ante savings represents all deemed/non-residential/downstream lighting measures

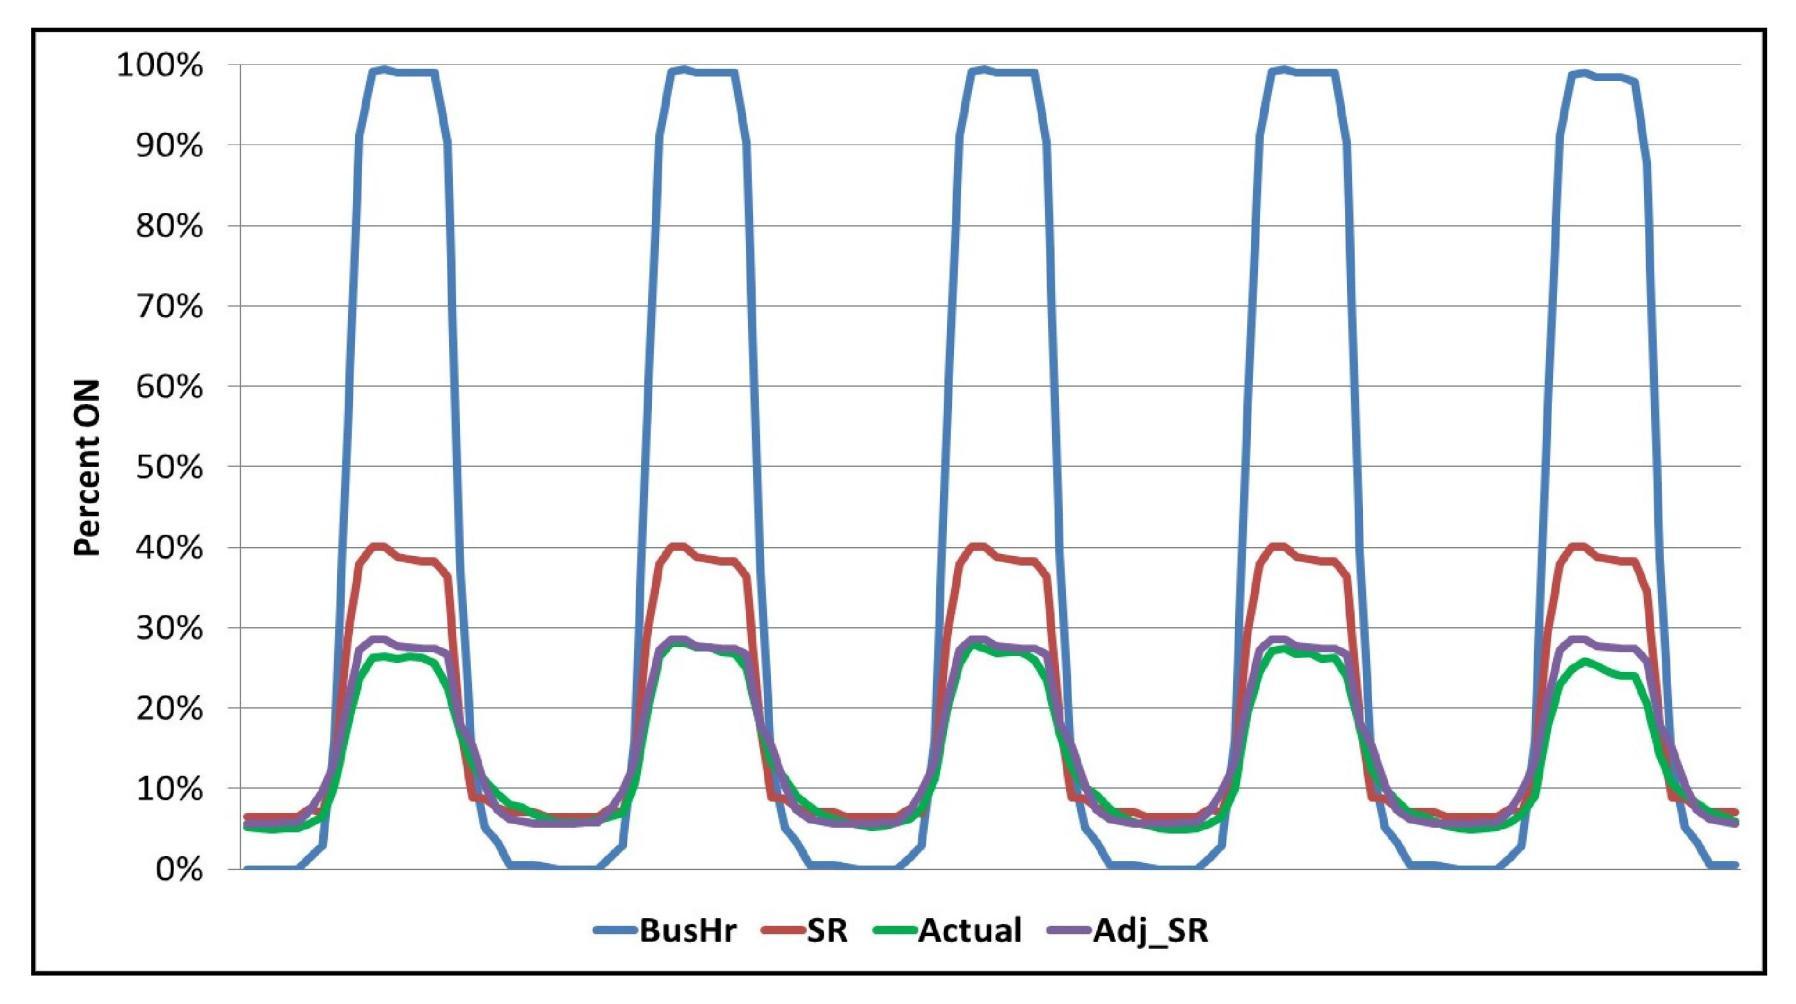
Example Application of Adjustments/Usage Rates for Small Office

- □ 9 week average
- □ Extrapolated to a full year (8,760 hours)
- Self-Reports and Business Hours
 - Business Hours
 - Identify open, closed, shoulder periods
 - Develop a usage rate (based on actual logger data) for closed and shoulder periods
 - □ Adjusted Self Reports
 - Ratio of actual usage to self-report during open hours

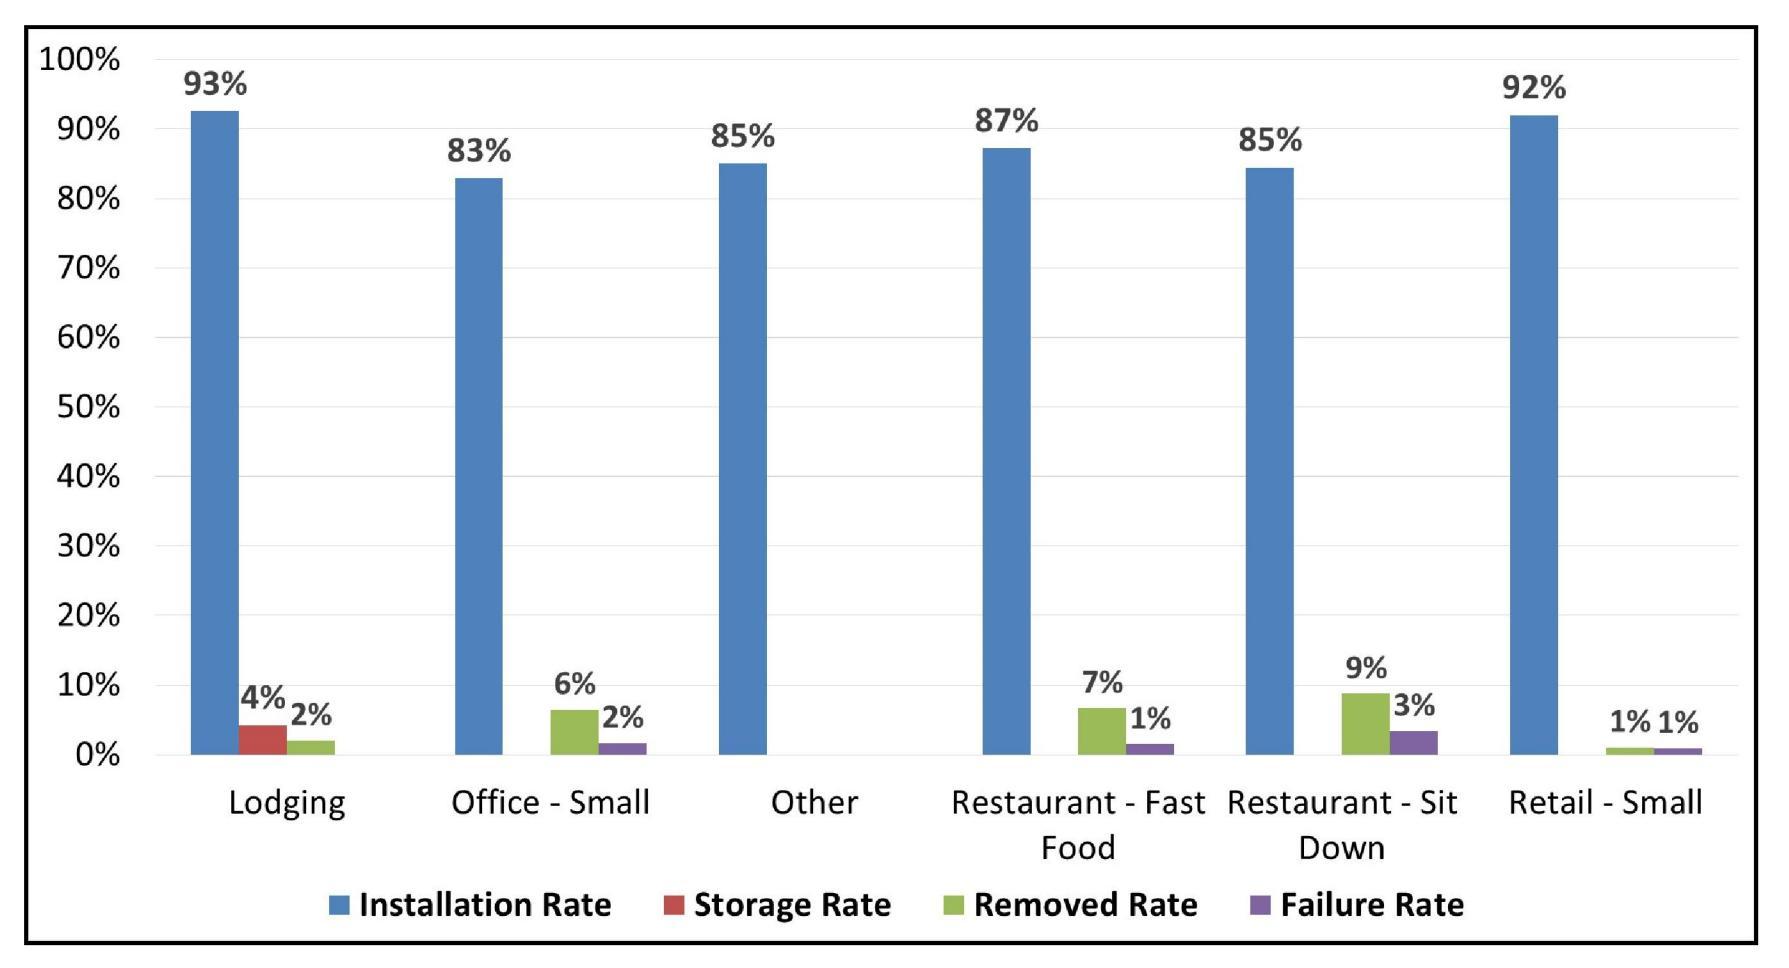
Installation Rates

LED A-Lamps

- □ 91% average
- Removal/storage/failure rates

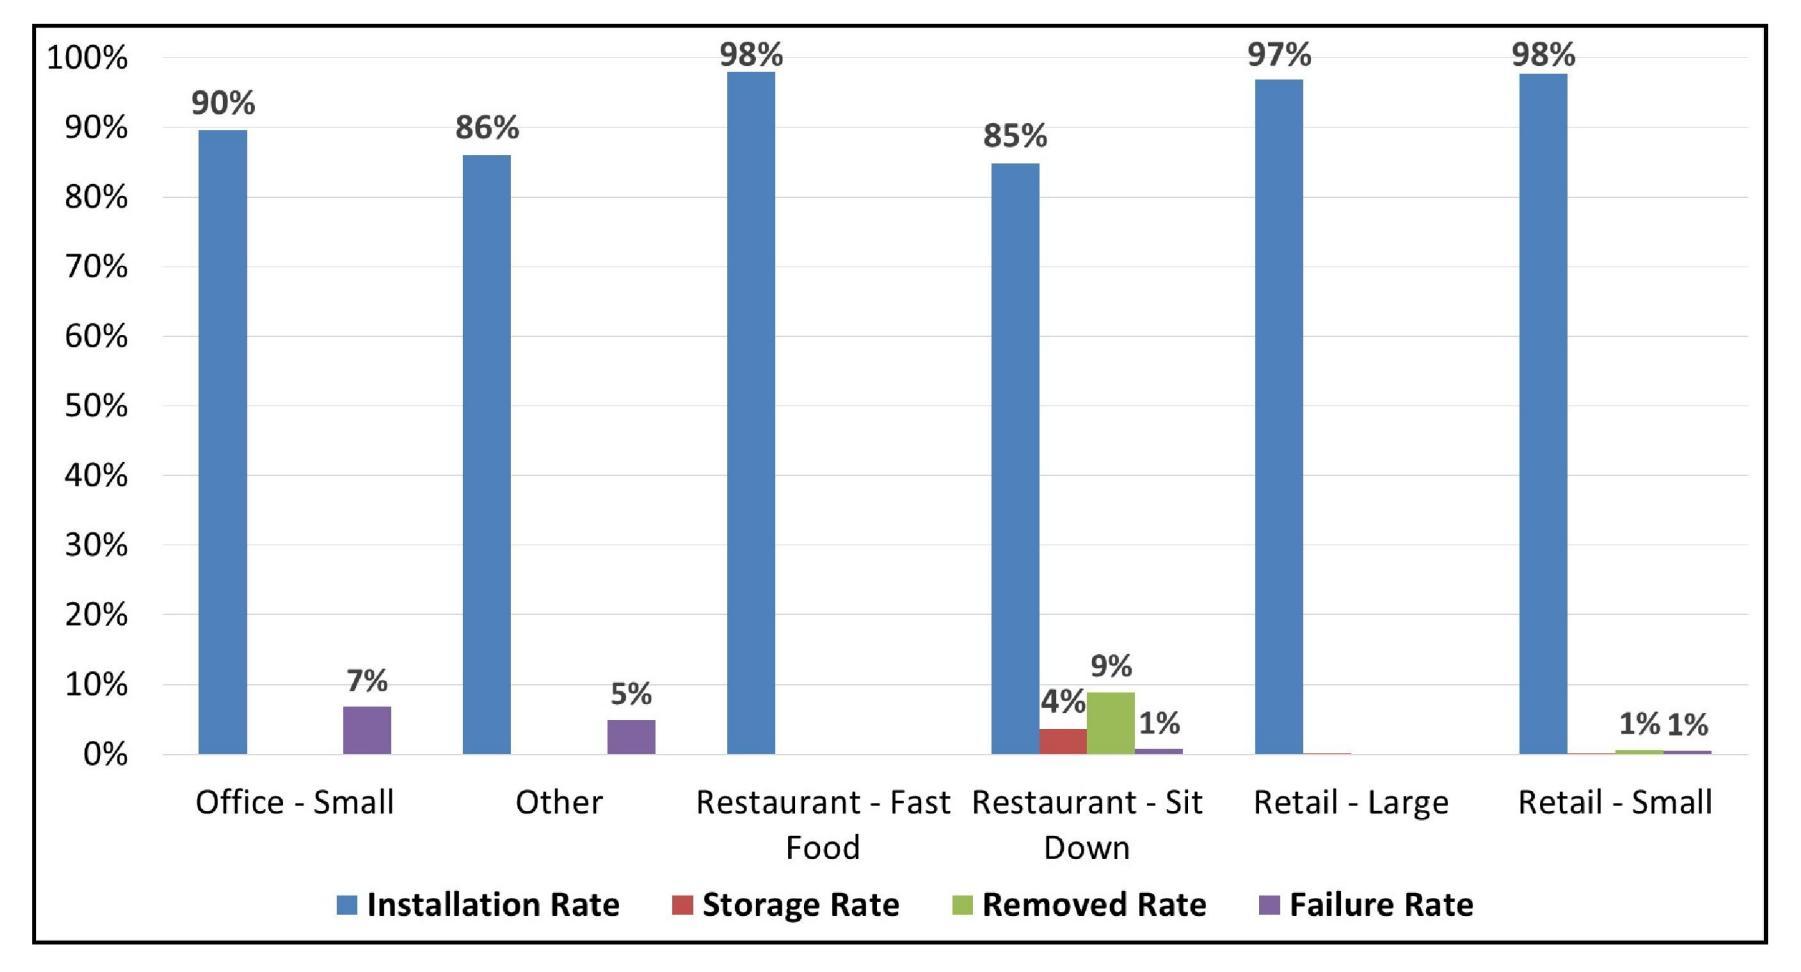
Installation Rates

LED Reflector Lamps

- □ 93% average
- Removal/storage/failure rates

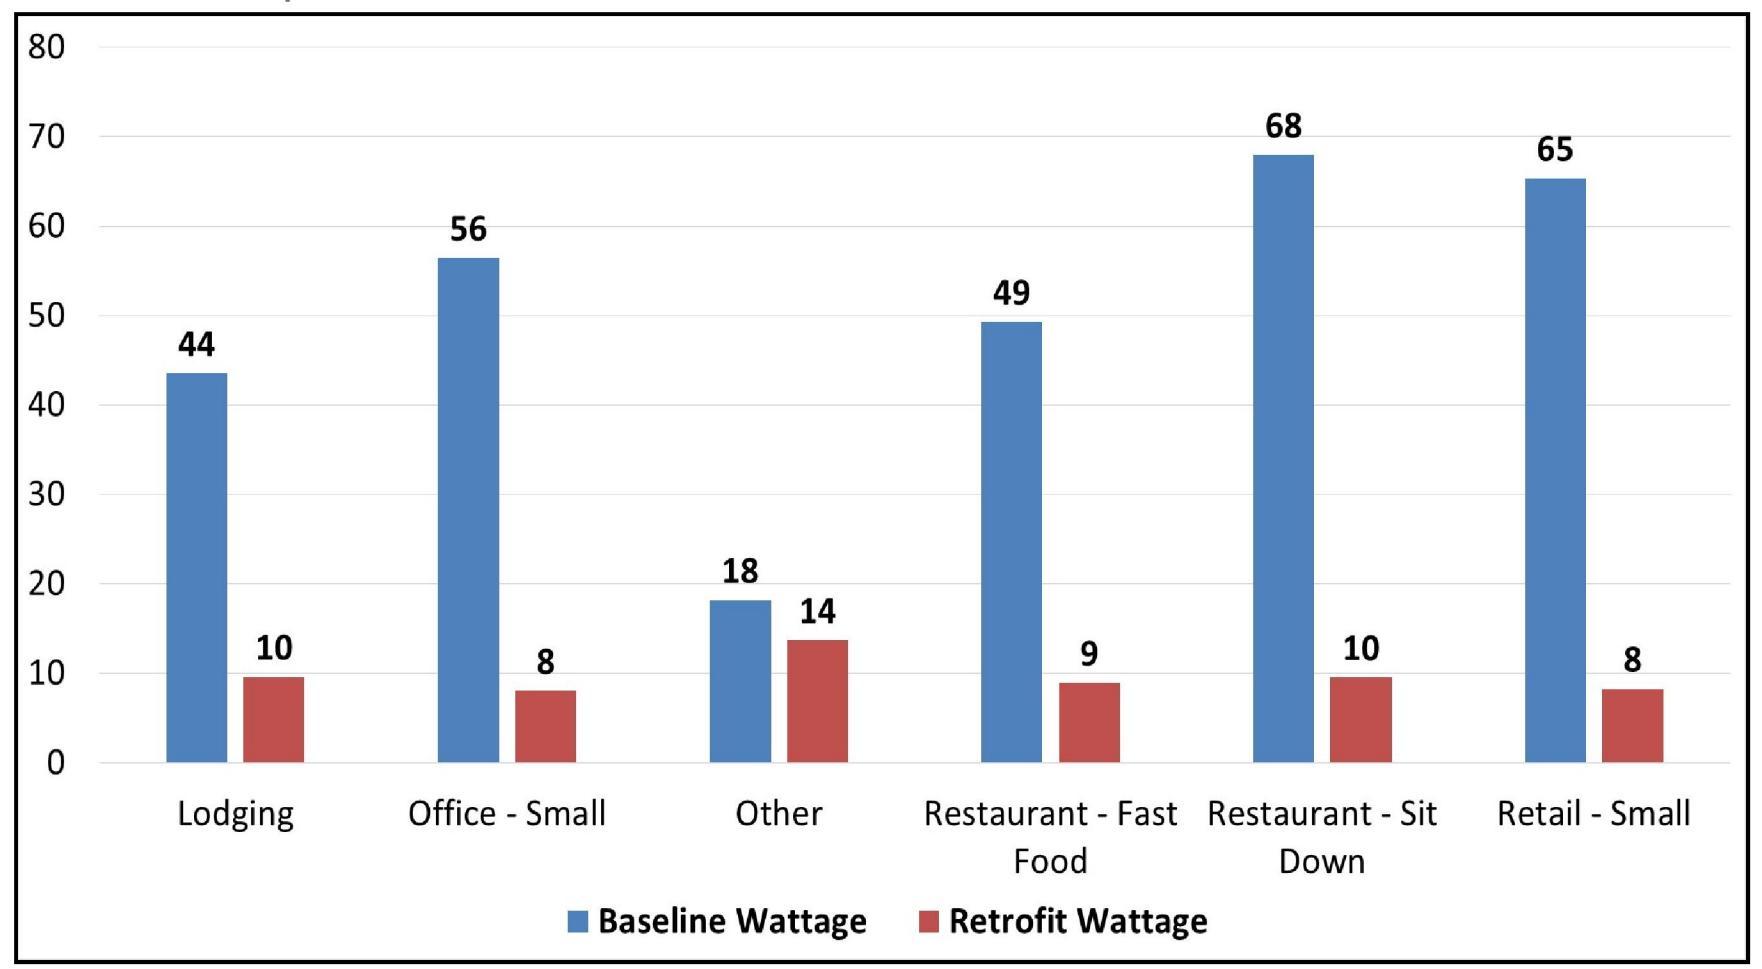
LED A-Lamps

- □ 9W average
- Generally replacing incandescent (some CFL)

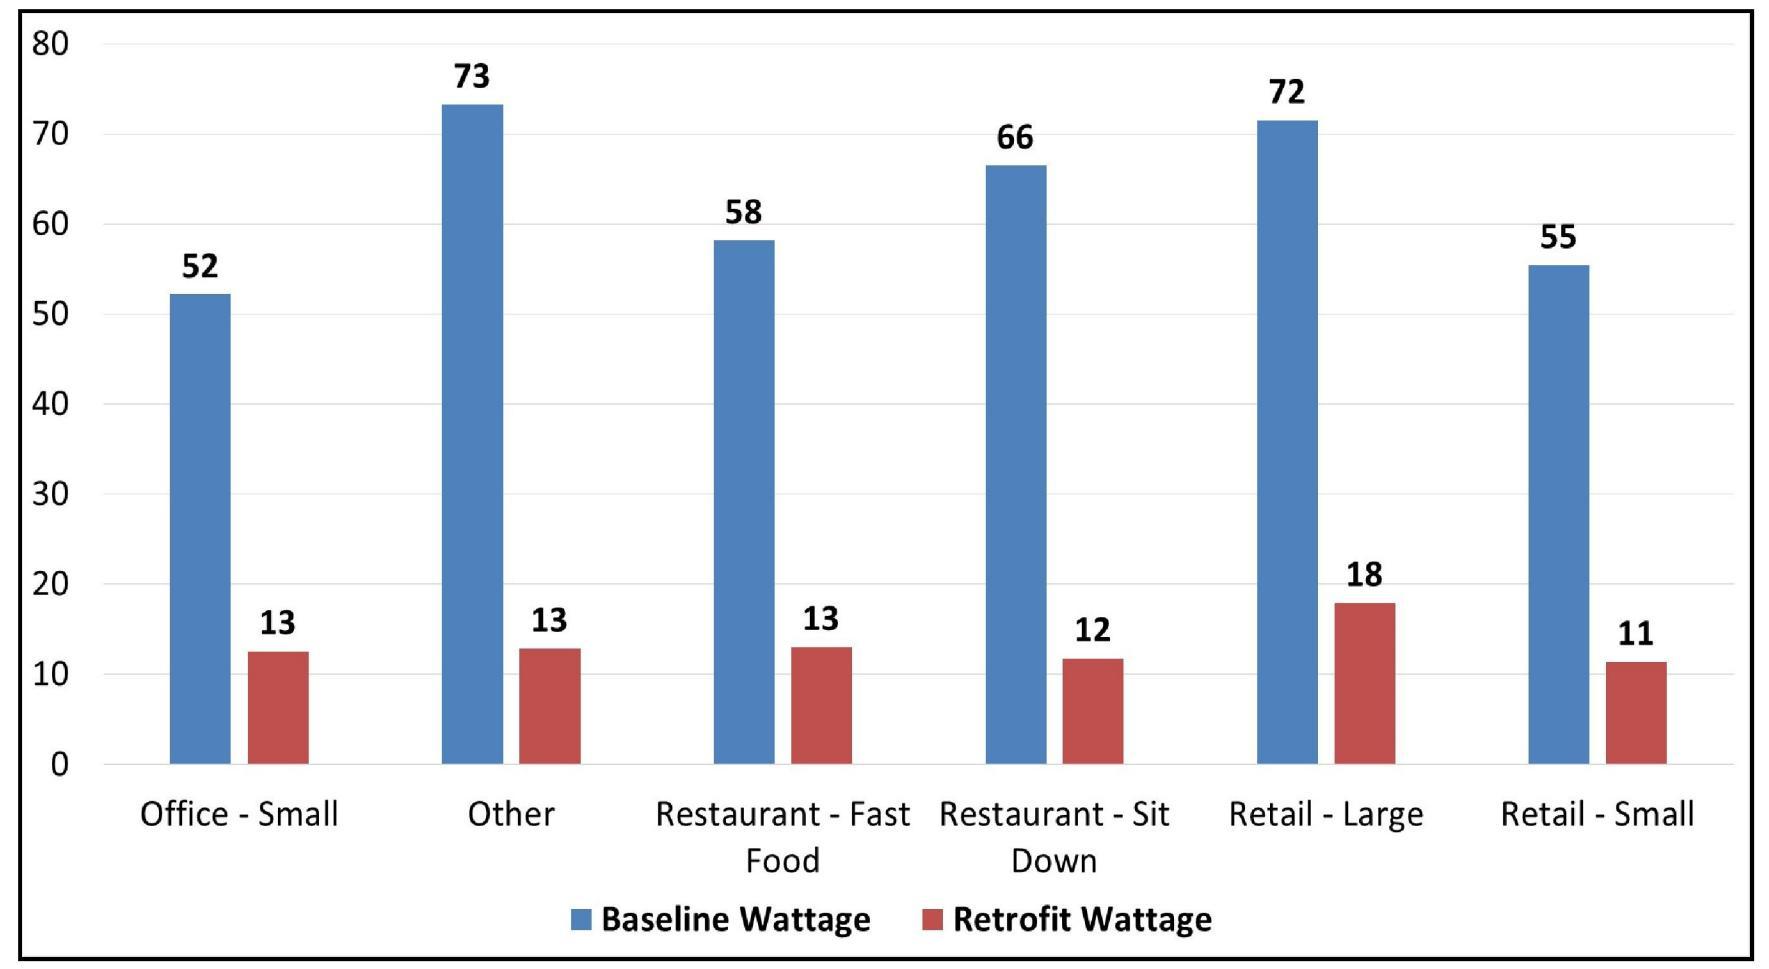
LED Reflector Lamps

- □ 13W average
- Generally replacing halogens (some CFL and incandescent)

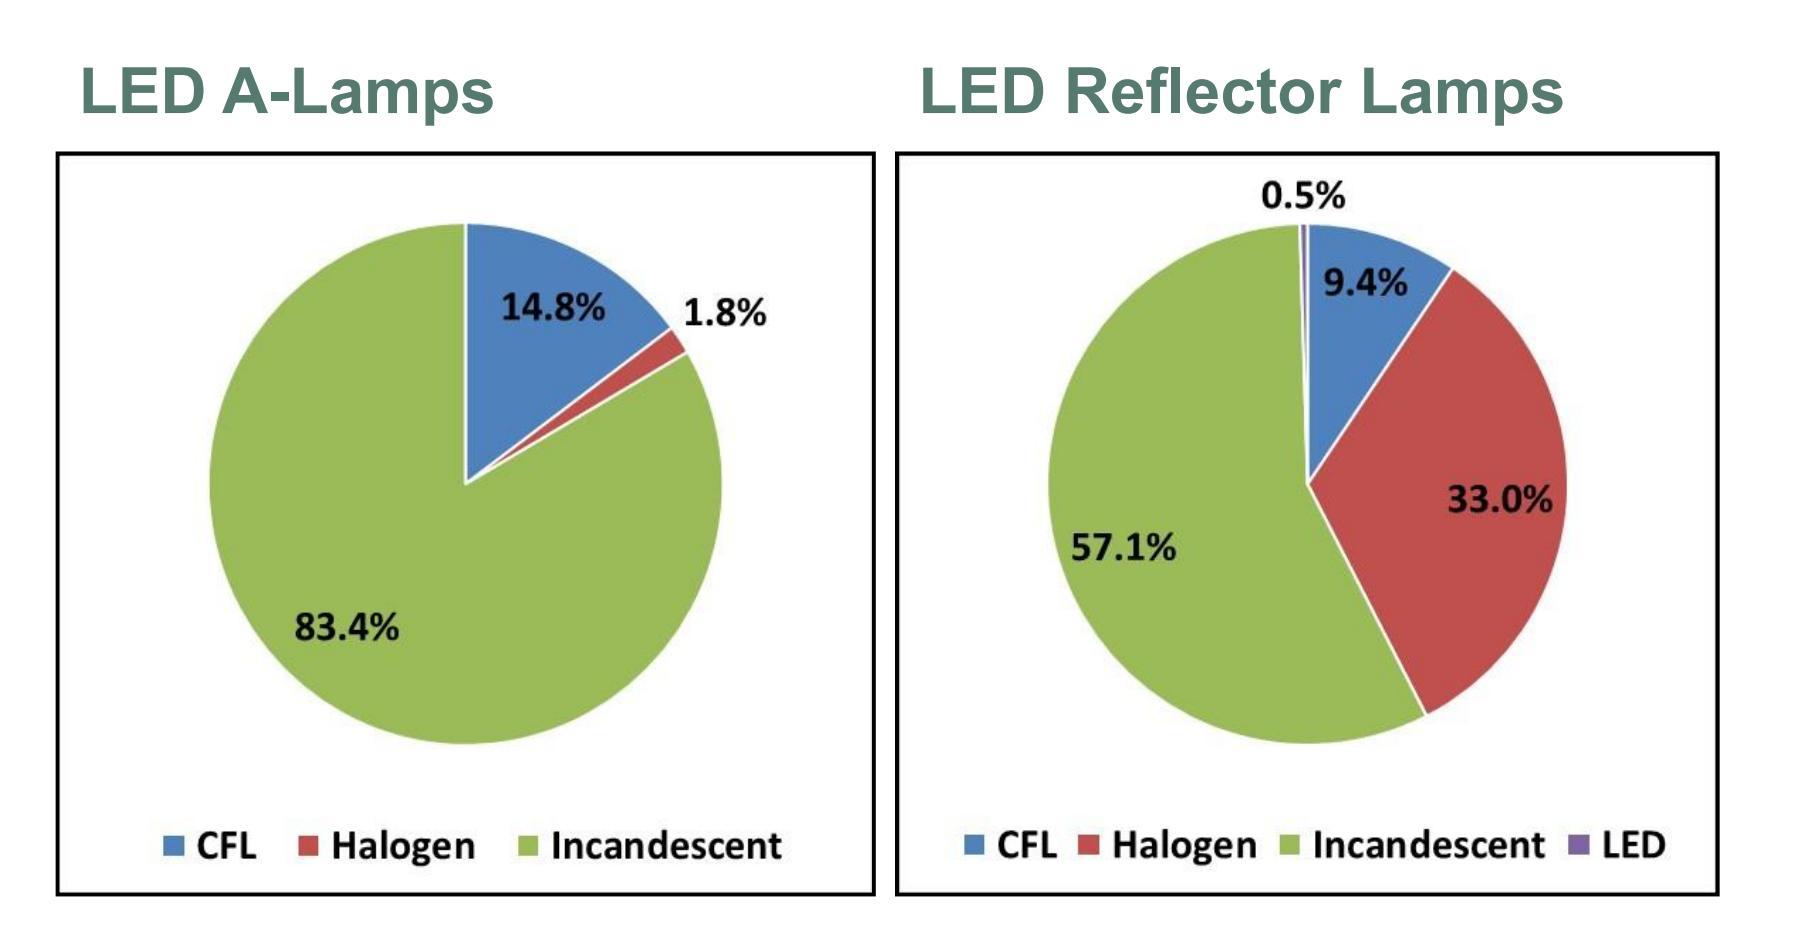
Distribution of Baseline Equipment

- Installed non-retrofitted equipment
- Baseline lamps in storage
- Review of any documentation
- Customer self-report
- Average wattages
